Confidential Inspection Report
2000 Square Feet
Brandon, MS

Prepared for: Typical New Home

Prepared by: Alpha Inspection
110 Woodlands Park Dr.
Brandon, MS 39047
601-992-4142 charlie@alphainspection.com

September 28, 2009

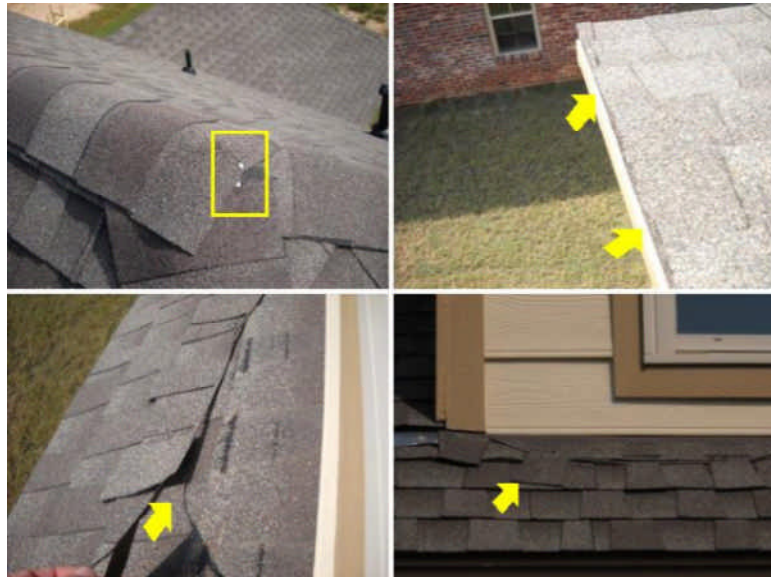
The shingles are in acceptable condition and well within their useful life. I test the condition of the shingles by placing the palm of my hand on the shingle, applying pressure and rotating it. The amount of granules that break free is an indication of the condition of the roof covering. Very few granules broke free from these shingles.

As best as I can tell the required two layers of felt are installed on the shed dormer roof.

There is an inadequate amount of shingles overhang on portions of the shed dormer roof. This condition can allow water to enter the overhangs of the roof and cause the wood to rot.

One shingle at the lower edge of the shed dormer is damaged.

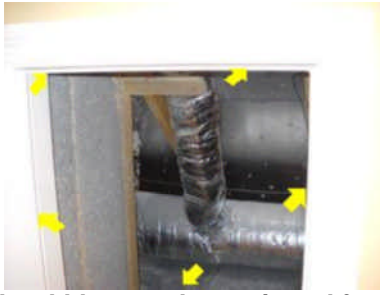
The door to the attic should be weather stripped for energy efficiency.

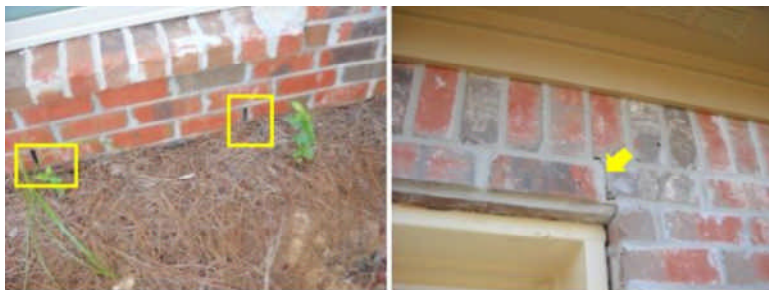
Brick veneer siding is now required to have weep holes (mortar vacancies every few bricks, allowing moisture to escape). Some of the weep holes are below the grading. When below grading, insects may enter the property more readily. At the very least a chemical barrier should be maintained to keep pests out of the home.

The cracks in the brick are typical for homes in this area. I found no evidence they are significant.

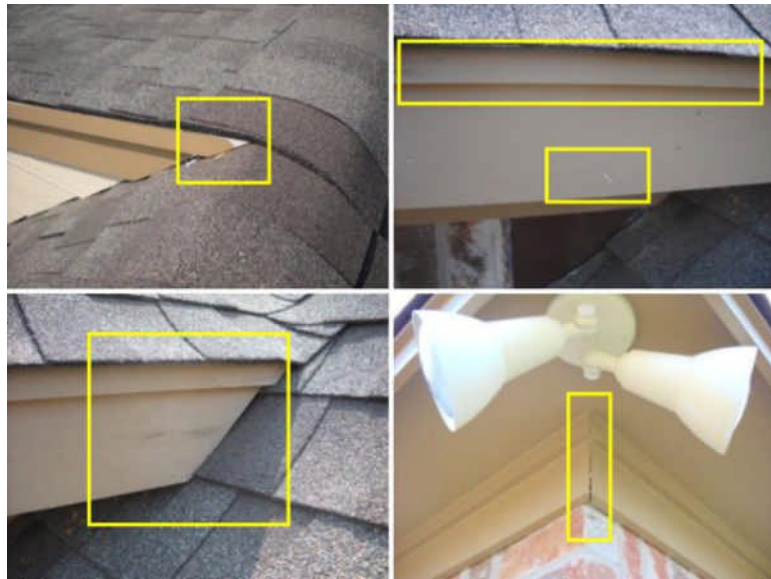
I looked for moisture damaged trim and probed any unusual looking areas. I found no moisture damaged trim.

The final application of caulk and paint has not yet been completed.

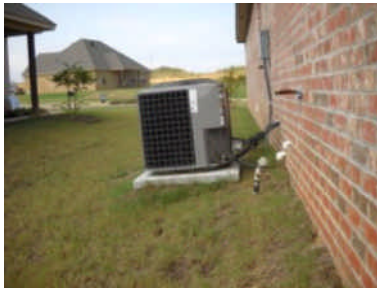
The compressor unit is not sitting level. It should be on a level platform.

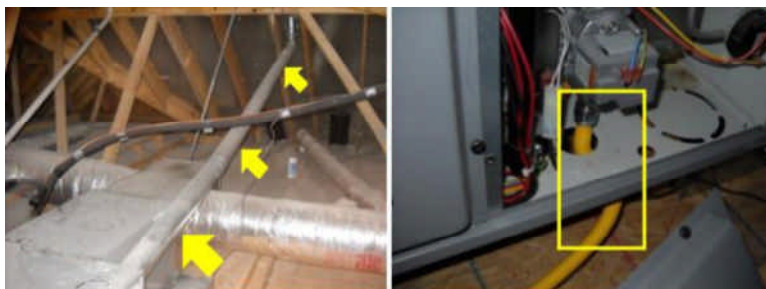
The ratio between the horizontal and vertical portions of this vent is not correct. This can create drafting and condensation problems. I

recommend a HVAC contractor who is knowledgeable of the GAMA venting requirements make corrections.

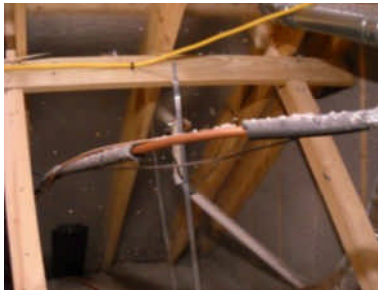
The compressor unit is not sitting level. It should be on a level platform.

The insulation is torn or missing from the refrigeration lines. This condition allows condensation to form on the refrigeration line and drip on to the surrounding areas.

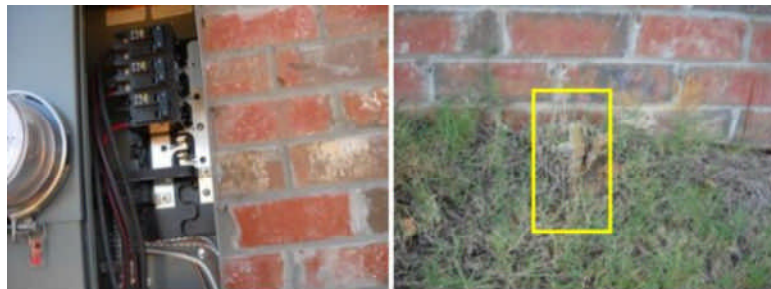
This is a 125 amp panel.

I recommend all defects be corrected by an electrician.

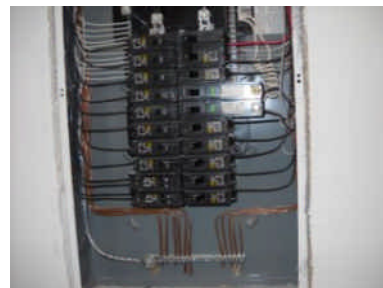
I found no defects at this panel.

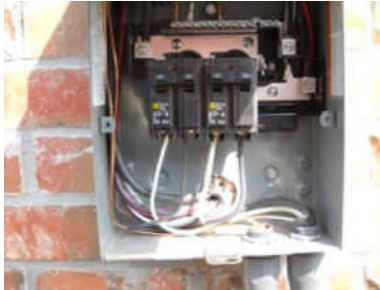
Everything within the panel is in good working condition.

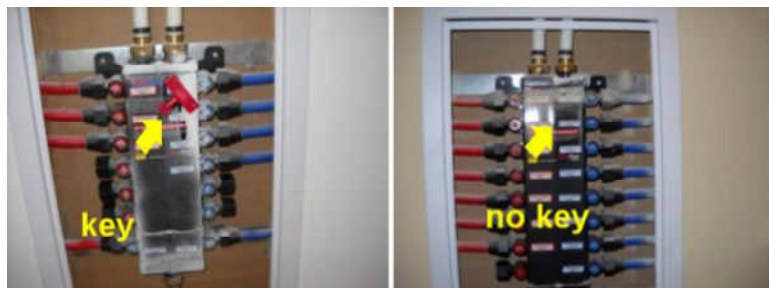
No leaks were found in the system and it is well installed.

No key is provided for the manifold in the pantry.

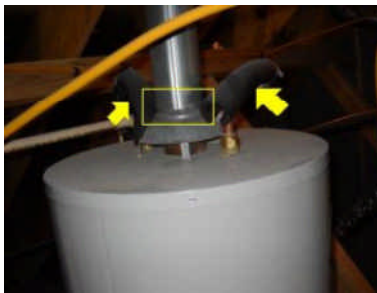
The black foam pipe insulation should not be within 6" of the water heater draft hood. It is a combustible material.

The lower end of this vent pipe has been cut. This is improper as it voids the UL listing and changes the clearance to combustible material requirements of the vent pipe. The vent pipe should be replaced.

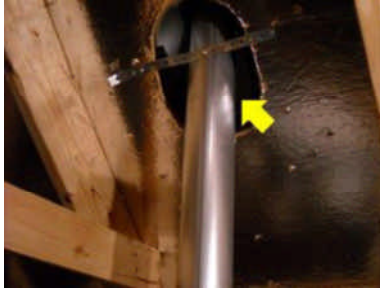
The black foam pipe insulation should not be within 6" of the water heater draft hood. It is a combustible material.

The lower end of this vent pipe has been cut. This is improper as it voids the UL listing and changes the clearance to combustible material requirements of the vent pipe. The vent pipe should be replaced.

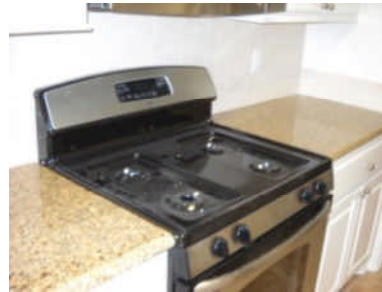
This appliance is not completely put together.

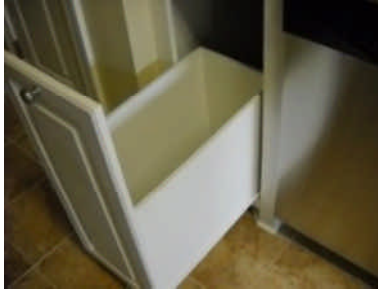
Some tightening and adjusting of the doors in the cabinets is needed.

Conventional drawer glides have been used for one pull out. They are not designed to carry the amount of weight they will be subjected to. I recommend a set of heavy duty full extension glides be installed.

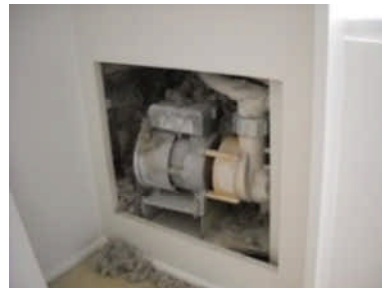
The hinges have not yet been installed on the access panel door.

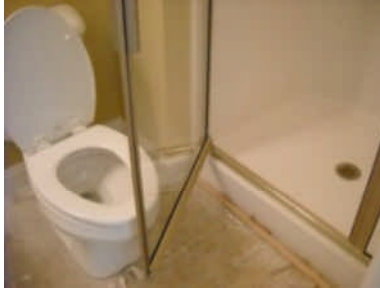
The toilet blocks the shower door from opening fully.

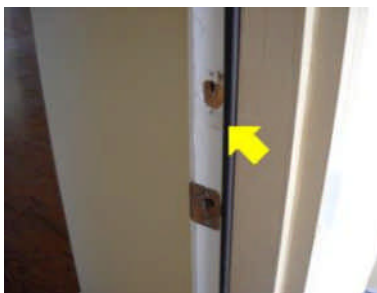
The front door is in need of additional coats of protective finish. Stained doors of this type need periodic maintenance. To properly protect the wood and finish they should be sanded and additional coats of finish applied every few years. It should be verified that the top and bottom edges are also sealed. These type doors often warp when these edges are left unsealed.

The strike plate for the deadbolt is not installed.

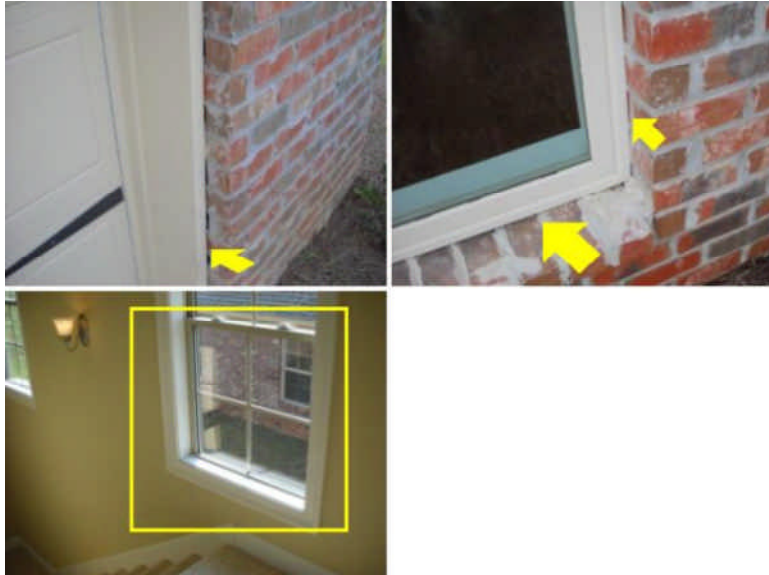
Seal the window casings and other dissimilar materials to the brick.

The window at the top of the stairs should have safety glass installed.

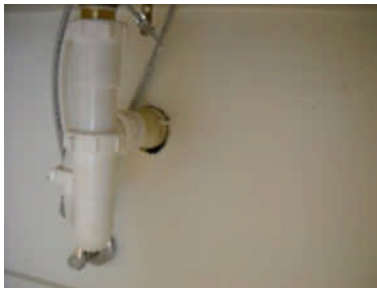
I recommend all penetrations in the wall system be sealed.

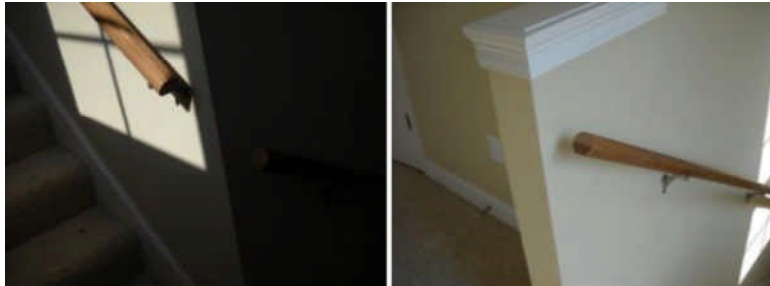
Handrails on stairs should be continuous and return to the wall at the ends. These do not meet these criteria.

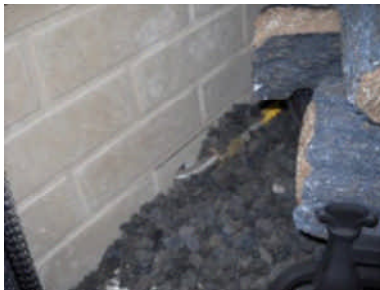
This is a vent free log set. It is important to leave the log set in the factory designed configuration. If you ever notice a soot (black) build up on the logs or inside the fireplace, discontinue use and have the appliance examined by a fireplace specialist or a competent plumber.

The appliance connector is improperly installed. It should not be installed in a manner where it can contact sheet metal. It should be connected to rigid metal pipe inside of the fireplace. Two appliance connectors have been used. This is also improper.
