Confidential Inspection Report
110 Greensview Dr.
Brandon, MS

Prepared by: Alpha Inspection
110 Woodlands Park Dr.
Brandon, MS 39047
601-992-4142 charlie@alphainspection.com

October 15, 2008

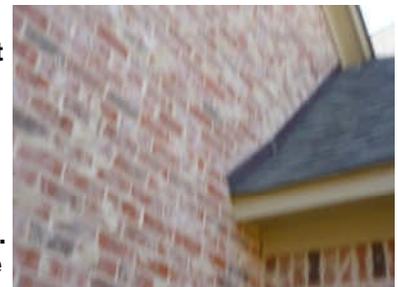
- CONDITION:** The roof to wall flashings have been installed in a manner that relies on a sealant to keep water out. This is improper. The Brick Industry Association (BIA) technical note # 7 (<http://bia.org/bia/technotes/TN7.pdf>) provides a detail of the proper way to install this flashing. It should have a stepped counter flashing "let" into the brick. I recommend the proper counter flashing be installed.

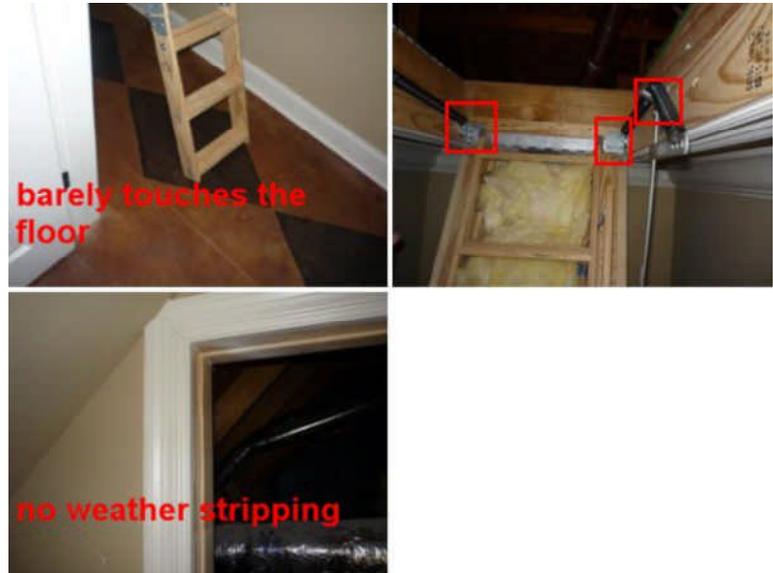
These stairs are located in an interior hall. This can allow unconditioned attic to be drawn into the home. There are products available to create an insulated seal over this ladder. I recommend you purchase one or construct your own.

The door to the attic should be weather stripped and insulated for energy efficiency.

The pull down ladder to the attic is not the correct model. It is too short for the ceiling height. It should be replaced with the correct model.

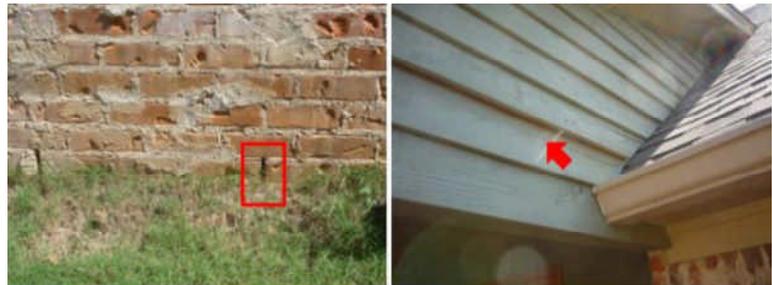
Bricks are required to have weep holes (mortar vacancies every few bricks, allowing moisture to escape). Some of the weep holes are below the grading. When below grading, insects may enter the property more readily. At the very least a chemical barrier should be maintained to keep pests out of the home.

A couple of pieces of siding at the back of the house are in need of a little repair. They are no longer secured to the framing.

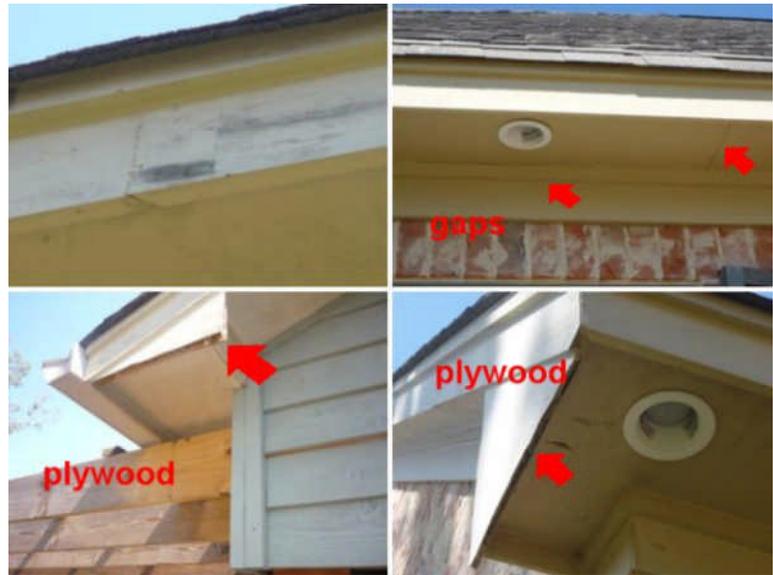
Some of the plywood used as trim material is delaminating. Others are in the early stages of this process.

There is quite a bit of mildew on this trim. There are products available to clean it off of the home.

The caulk around the trim is cracked. It is time to recaulk and paint the trim.

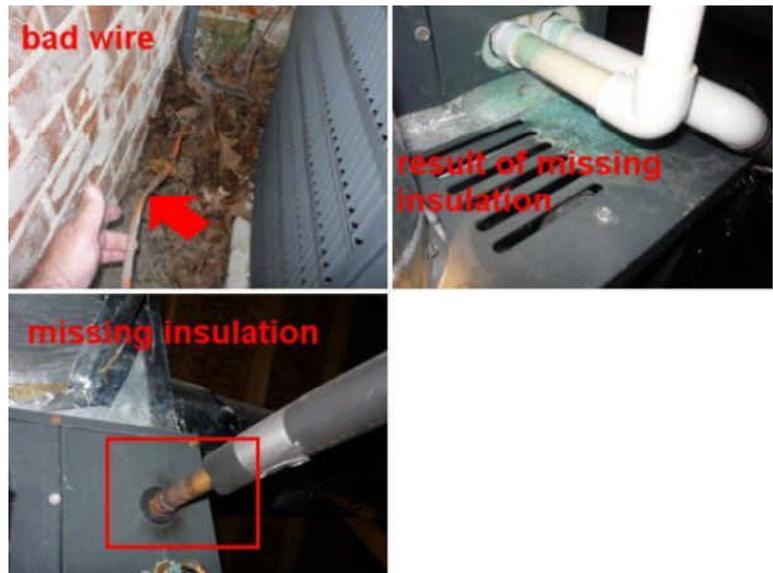
This condensing unit is installed in a manner that makes it difficult to work on the unit. It should not have been placed in a corner like this.

The compressor unit is not sitting level. It should be on a level platform . I recommend this be corrected when the unit is serviced or repaired.

A bit of insulation is missing from the refrigeration line. This condition allows condensation to form on the refrigeration line and drip on to the surrounding areas. This should be corrected.

A proper disconnect is not supplied to this unit. This is unsafe for anyone

The wire used to supply this unit with power is improper. It is not rated for burial and is not buried at a sufficient depth. It is also too small for the current demand of the unit.

The condensing unit started making an unusual buzzing after running for an hour or so. This should be investigated and any needed repairs made.

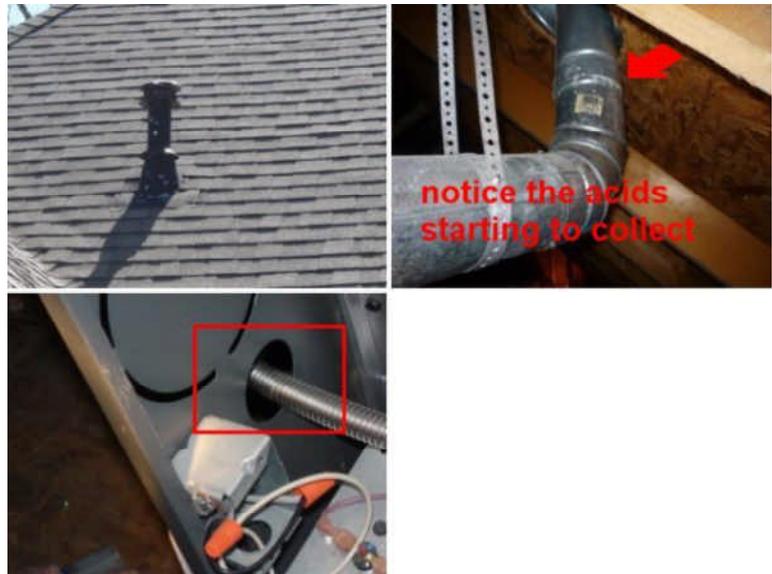
The vent pipe of this appliance should terminate higher above the roof than it does. Have this corrected by an HVAC contractor who has a good understanding of the GAMA venting requirements.

The vent is not installed in accordance with the Fuel Gas Code. The total horizontal length of a vent shall not be greater than 75 percent of the vertical height of the vent. Have this component corrected by an HVAC contractor who has a good understanding of the GAMA venting requirements. There are signs this appliance is not venting properly.

Wood is within one inch of the vent pipe. This is a fire hazard. Either relocate the pipe or remove the wood.

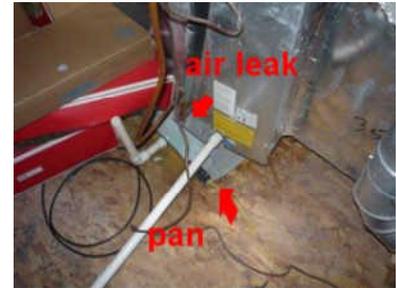
The compressor unit is not sitting level. It should be on a level platform. I recommend this be corrected when the unit is serviced or repaired..

A bit of insulation is missing from the refrigeration line. This condition allows condensation to form on the refrigeration line and drip on to the surrounding areas. This should be corrected.

The condensate overflow pan is not centered under the evaporator. If water leaks out of the evaporator the ceiling below will be damaged. The pan should be properly centered under the unit and secured in place.

Conditioned air is leaking out of the evaporator. This effects the unit's performance and should be corrected.

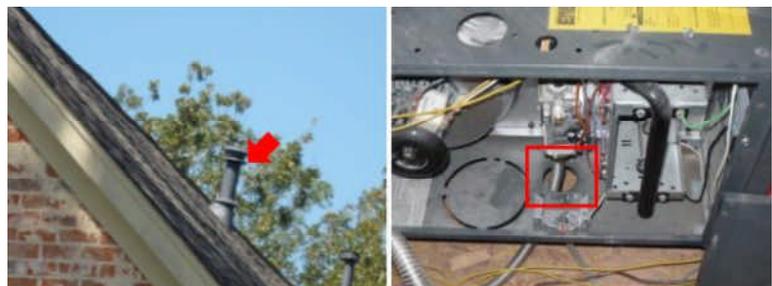
The vent pipe of this appliance should terminate higher above the roof than it does. Have this corrected by an HVAC contractor who has a good understanding of the GAMA venting requirements.

The flexible gas connector should not enter the furnace. This violates the listing of the connector. It should be connected to a rigid metal pipe that exits the furnace cabinet.

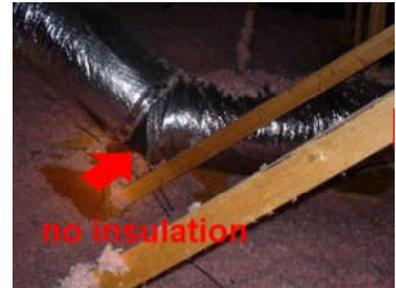
The flexible duct is not properly supported and not insulated in one area. This can restrict air flow and affect the unit's performance.

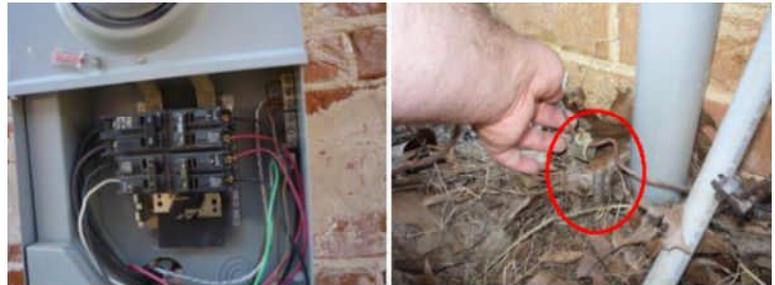
The screw used to hold the cover onto the panel is missing. This creates an unsafe condition and should be corrected by installing the appropriate screw.

These breakers are not labeled. I recommend they be labeled.

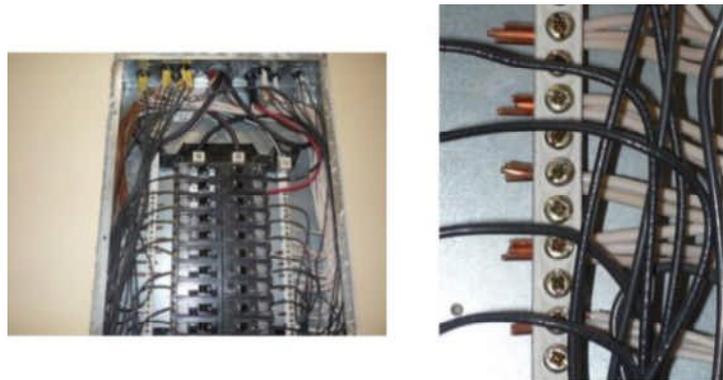
This panel does not meet current safety guidelines. It has a four wire feed but it is not configured in a manner that can correctly utilize the four conductors. All of the neutral and ground wires are bonded together. This practice, common to our area is improper. The simple solution is to have a terminal strip installed and bonded to the panel. All of the ground wires

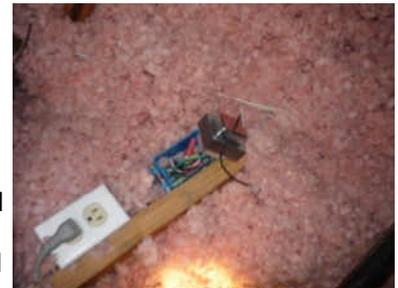
The transformer for the door bell is installed in a manner that leaves the wiring in the junction box exposed. This is improper and creates an unsafe condition.

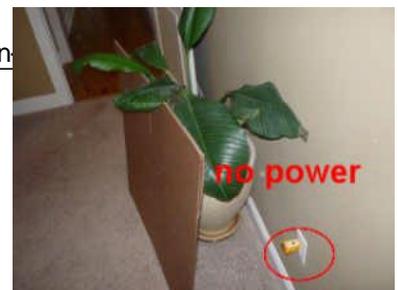
One of the outlets in the master bathroom is not GFCI protected. This condition does not provide the level of protection required when this home was built. A GFCI outlet should be installed at this location.

One outlet in the master bedroom tested to not have power. This should be investigated and corrected.

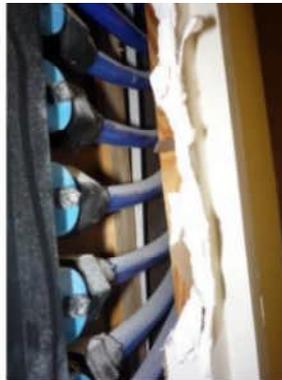
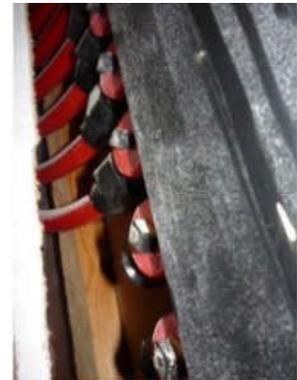
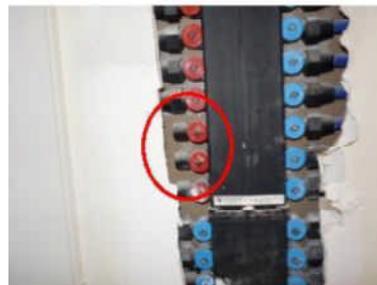
The installation instructions for the manifold system (<http://www.vanguard.ca/pdfs/ManablocInstallInst.pdf> page 8) directs the

installer to drill an individual hole for each PEX tube connected to the manifold. This is to provide support for the tube and to keep the manifold ports free of stress. In this installation long slots were cut into the wall studs to allow the tubing a path to the manifold. This puts the manifold ports under stress.

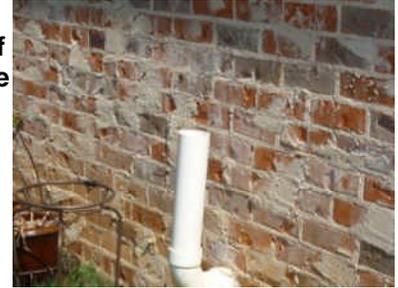
What I believe to be a waste clean out is protruding out of the brick on the left side of the house. I recommend it be cut off and the appropriate clean out fittings installed.

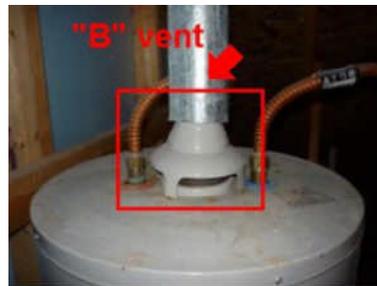
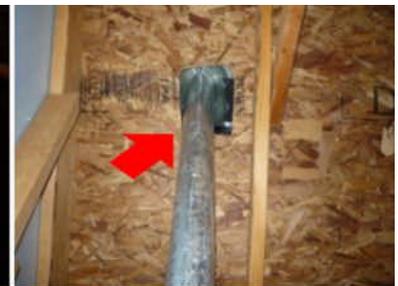
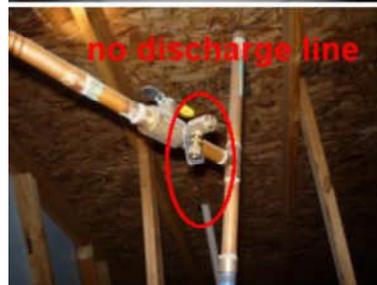
The flue should have one inch of clearance from all combustibles materials. Inadequate clearance was found at the roof decking.

The flue pipe is missing the required screws that hold it to the appliance. These are needed to prevent the flue from moving out of alignment with the draft hood.

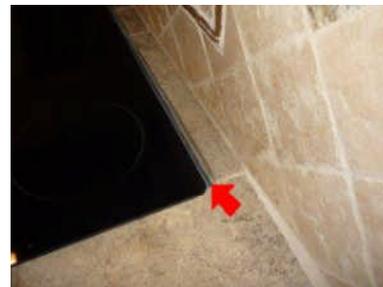
The range is missing the anti-tip bracket. These became standard on ranges about eight years ago. This range should have a bracket installed. I recommend you have one installed.

There is a gap at the back of the range.

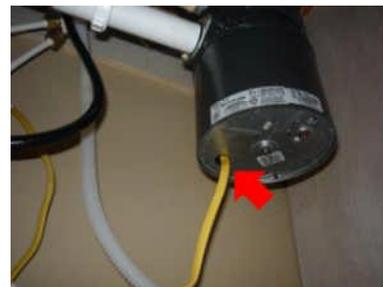
CONDITION: **There should be a romex clamp installed on this appliance. It is not installed.**

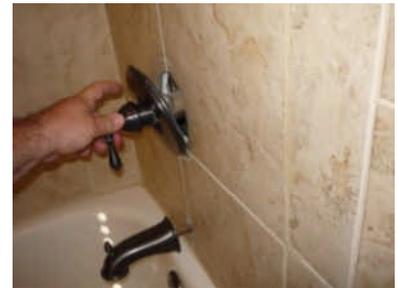
This fixture is not secured to the framing in the wall. This should be corrected to prevent water leaks from developing.

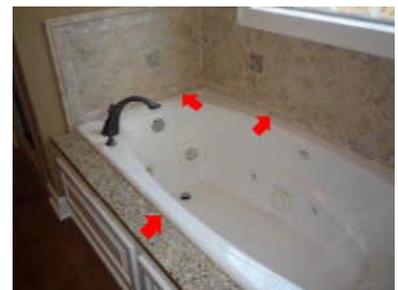
Maintain a good caulk seal at all tub and shower areas as a precaution against water entering the walls. This is important! This needs to be done now.

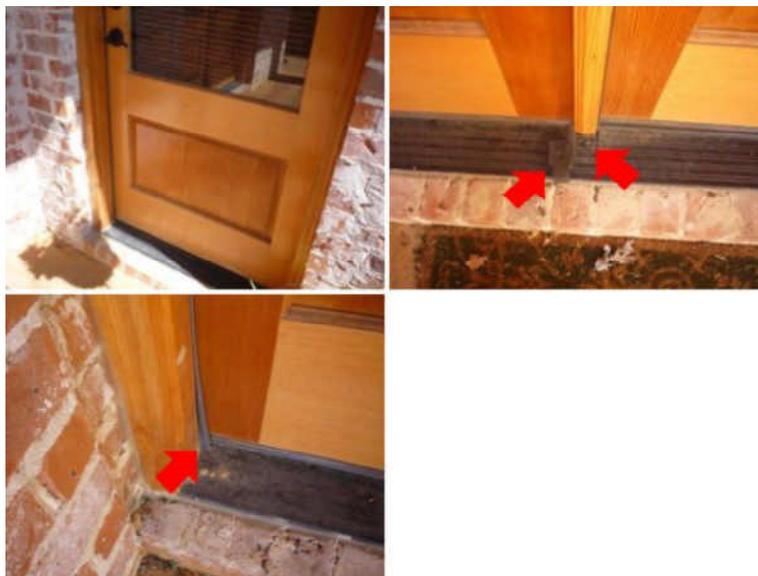
Stained doors of this type need periodic maintenance. To properly protect the wood and finish they should be sanded and additional coats of finish applied every few years. It should be verified that the top and bottom edges are also sealed. These type doors often warp when these edges are left unsealed. This should be done now.

The door bumper has come loose from the front door.

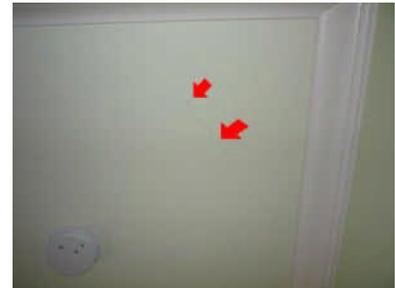
There is a damaged area in the ceiling of the back bedroom. I could not find any cause.

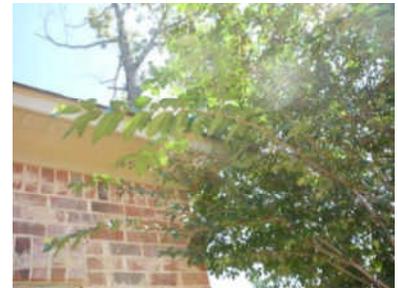
CONDITION: Trees are planted close to the house. They should be kept trimmed back, away from the house or removed to prevent damage to the home.

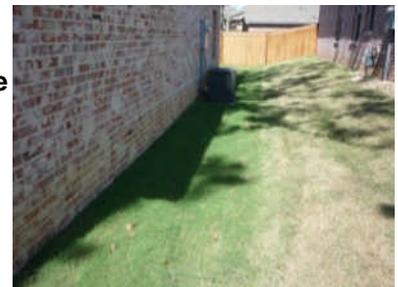
SITE: **The grading on the right side of the house directs water toward the foundation. This condition should be corrected as it can have negative effect on the home.**

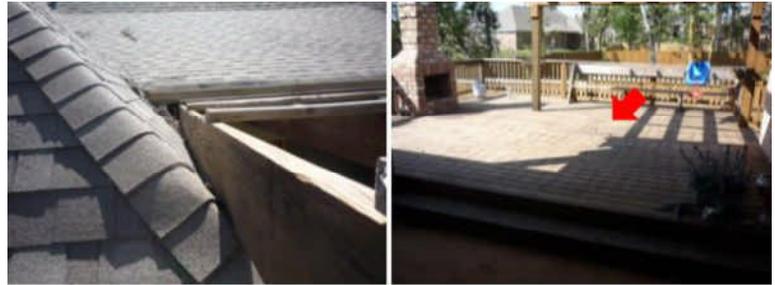
There is a pronounced dip in the deck. Some of the framing and deck boards are pulling free. Have a carpenter you trust provide a proposal for the needed repairs.

A piece of the lumber used to build the arbor over the deck is in close contact with the roofing shingles. I am concerned that the trapped debris will act as a dam and cause water to enter the attic space. This should be corrected to allow free passage of any debris and rain.

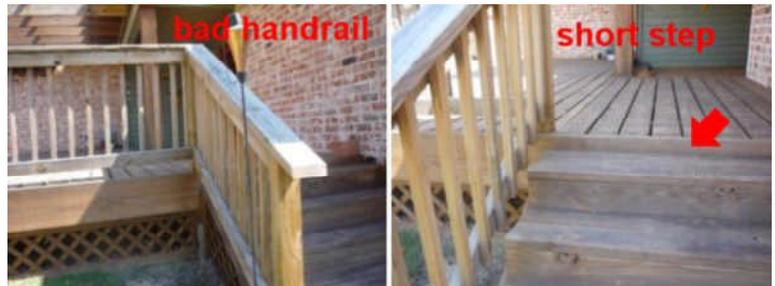
Current safety guidelines require all steps to be approximately the same height. This is not the case on one set of deck stairs.

Handrails must be easy to grip. These handrails did not meet this criteria. They should be replaced with rails that meet current safety guidelines. More injuries occur on the stairs in a home than any other location.
