Confidential Inspection Report
110 Greensview Dr.
Brandon, MS

Prepared by: Alpha Inspection
110 Woodlands Park Dr.
Brandon, MS 39047
601-992-4142 charlie@alphainspection.com

October 15, 2008

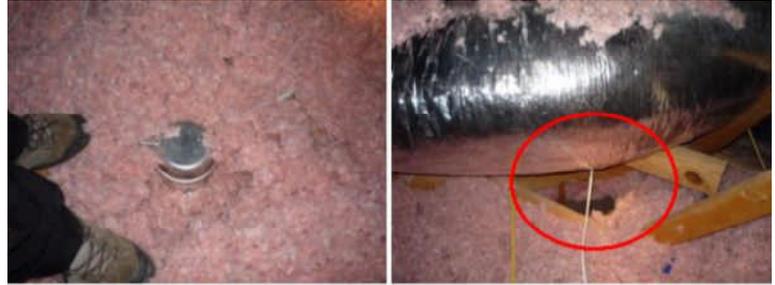
**INSULATION
TYPE AND
CONDITION:**

Blown fiberglass has been used to insulate this attic.

The insulation is well distributed and is in good condition.
